# Quick detection of high oxidant levels by 3D TRASAR™ Technology for Membranes and System Assurance Center prevents membrane damage

CASE STUDY - FOOD & BEVERAGE

CH-1995

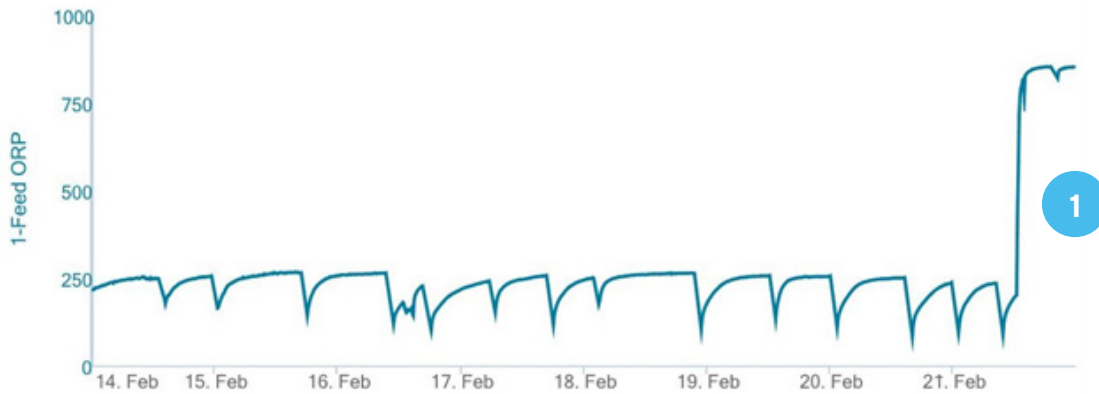
In mid-February, the membranes on both trains of the RO system were replaced. The System Assurance Center performed a data check and revalidated the alarm limits on the 3D TRASAR controller. Nine days later, the sodium bisulfite inventory was depleted due to a higher-than-normal demand. Plant personnel were unaware of this situation.

This situation allowed high-oxidant water to enter the RO unit. Left unchecked, this situation would have damaged the new membranes and possibly forced their untimely and costly replacement. Thankfully, the high oxidant levels triggered a high Feed ORP alarm on the 3D TRASAR controller. The System Assurance Center received and addressed this important alarm immediately. Figure 1 shows the data points that triggered the alarm.

**Figure 1 - 3D TRASAR data from the event**

1. System Assurance spots high oxidant levels and alerts local Nalco Water contact

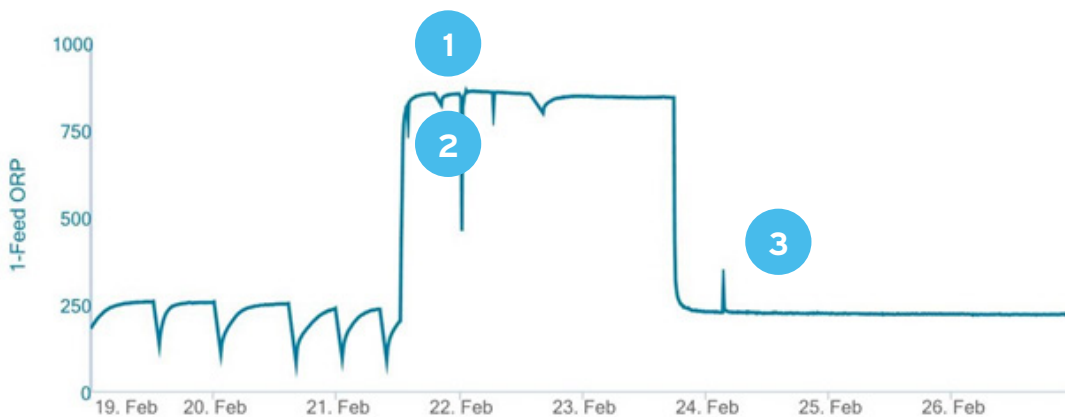
**Figure 2 - Feed oxidant levels before & after implementation of recommended corrective action**

1. System Assurance spots high Feed oxidant level and alerts local Nalco Water contact
2. Rush order of sodium bisulfite is placed
3. Feed oxidant levels return to normal after bisulfite feed restart

After analyzing the RO unit's 3D TRASAR data, the System Assurance Engineer immediately identified the most likely causes of the high oxidant levels. A detailed alarm analysis with recommended corrective actions was sent by e-mail to the customer and the local Nalco Water Sales and Service team. The System Assurance Engineer also followed up with the Nalco Water Sales Engineer via phone.

After the Sales Engineer confirmed the issue's root cause, a rush order for sodium bisulfite was placed. This quick notification also enabled the customer to take additional steps to minimize membrane damage by ensuring that the feedwater's free residual halogen (FRH) levels did not exceed 2.0 ppm. The bisulfite was delivered two days later, and product feed was restarted. This action brought the Feed ORP levels back down to acceptable levels. See Figure 2 for details.
