Cleaning Program for Rhombic Sulfur deposits in Geothermal Power Plant Increases Electric Power Generation by 3 MW in a 26.8 MW unit

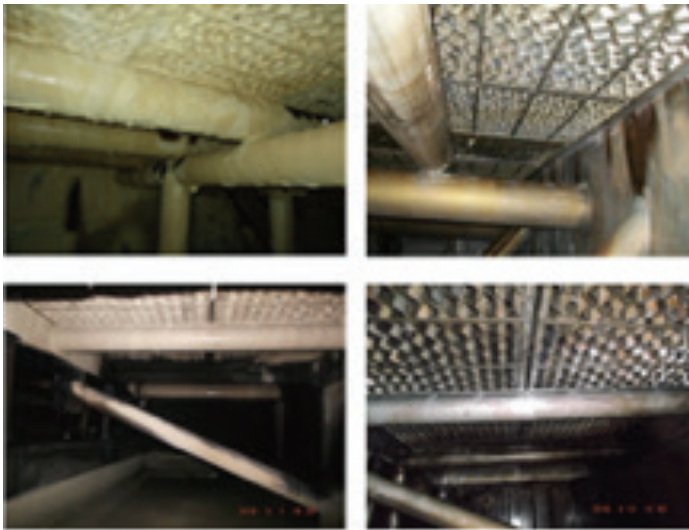
The first unit, with initial capacity to produce 26.8 Mw, was producing only ~19.5 Mw. When the unit was taken offline, serious sulfur fouling was found in its condenser fill.

Image 1 - Barometric condenser fill, before and after chemical cleaning

The sulfur deposits were eliminated by solubilizing their supporting salts and breaking down the sulfur macro crystals, using a highly alkaline solution developed by Nalco Water. This solution, which contained a high concentration of caustic soda and caustic potash enriched with emollients, wetting agents and caustic inhibitors, was used in a chemical cleaning program at high-temperature conditions (above 60o C), that recirculated the solution through the barometric condenser.

Employing all necessary safety measures, and leveraging extensive Nalco Water experience in chemical cleanings, the customer and their contractor effectively removed 98% of the rhombic sulfur deposits in the condenser—recovering the unit’s capacity.

As a result of the chemical cleaning program recommended and advised by Nalco Water, the unit reported a three-Mw/Hr increase in electric power generation per unit once placed back in operation.
