# Nalco Cast Clean™ Improves Thin Slab Caster Plant Profitability by more than \$5.9 million per year

CASE STUDY - PRIMARY METALS

CH-1472

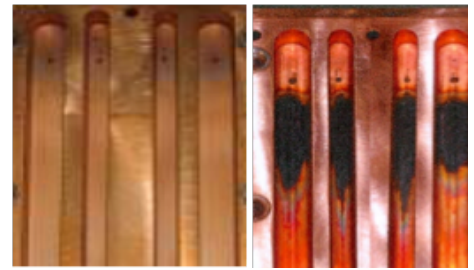
Nalco recommended the utilization of its Nalco Cast Clean mold water treatment service to improve the performance of the Mold Water System and reduce longitudinal cracking. Nalco Cast Clean service combines:

- Nalco TRAC™ Inhibitors and biocides engineered for High Heat Flux Mold Systems
- Real-time Inhibitor Control using Advanced 3D TRASAR® Automation
- Web-based Monitoring of Critical Leading Performance Indicators
- 24/7 Mold System Health Check with Nalco 360™ Service
- Application of Nalco Global Mold Water Best Practices

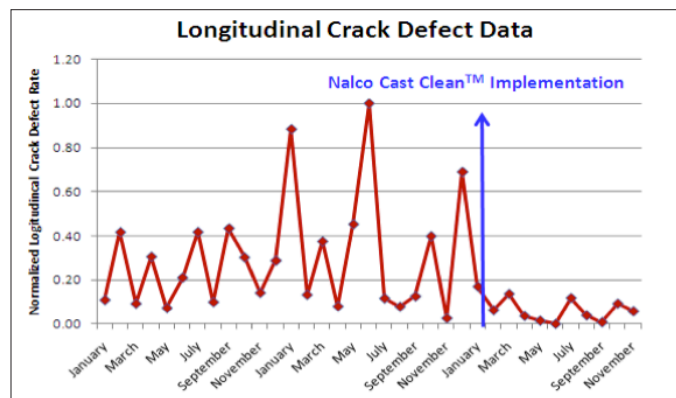
After the Nalco Cast Clean service was implemented, an immediate improvement in product quality, mold cleanliness, and mold life were noted. The frequency of longitudinal crack defects dropped by more than 81% and resulted in 7,000 fewer tons of steel that were rejected either internally or externally by the customer. In addition, mold campaign life was increased by 63% and casting speeds were increased by 2% without any increase in the longitudinal crack frequency rate.
